SNV024, SNV024GQ

Captiva CG

Engines Z22D1 2.2 Litre Turbo Diesel

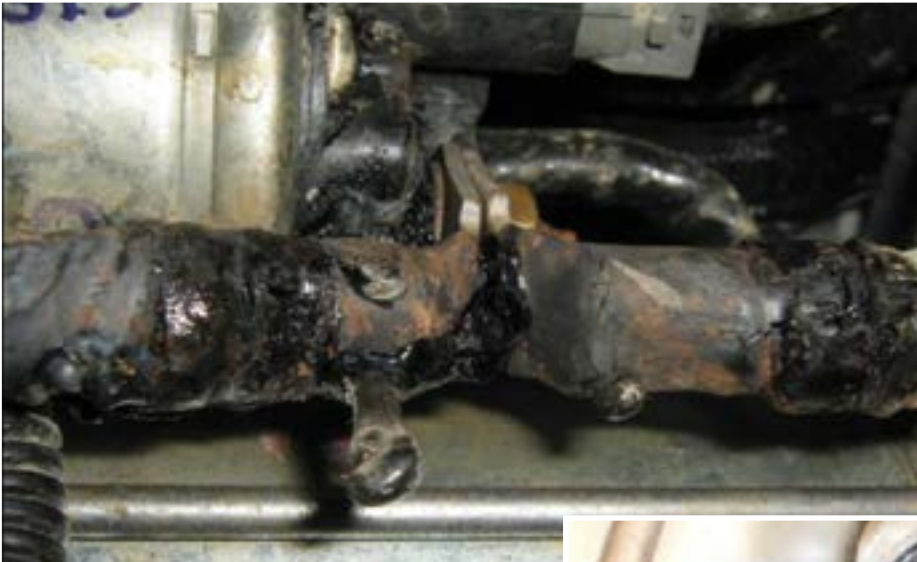
JAS has been made aware of an issue with the wiring on the vehicles, that these Starter Motors are fitted to, causing the solenoid main battery cable terminal on the Starter to overheat and fail.

The main battery cable which supplies the Starter Motor with its battery supply has a connection to the Alternator output at the Battery stud on the Starter. This is a 2 piece joint with potential for resistance. The Alternator, being a high output unit charges the battery through this connection. Any resistance causes heat and this connection to eventually develop into an open circuit.

See pictures below. We have seen this issue on aftermarket and genuine starters.

Any potential for resistance at this point **MUST** be resolved when a new starter is fitted.

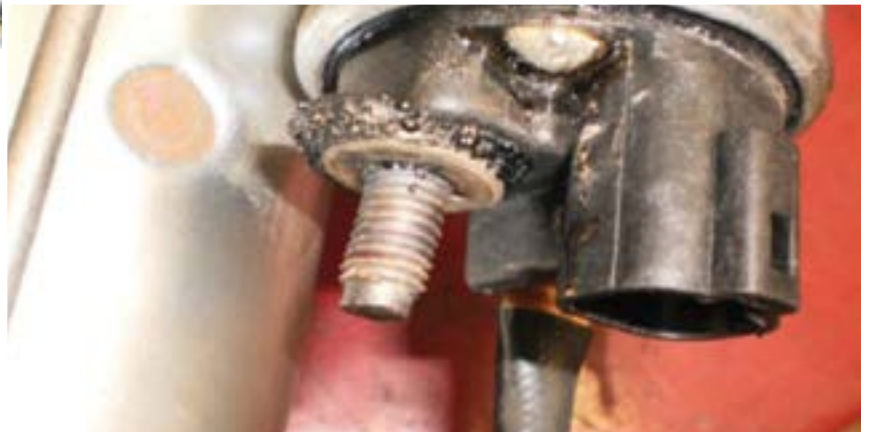
This damage to the Solenoid Stud is **NOT** a manufacturing defect but caused by external heat and any starter returned with this problem will **NOT** be covered by warranty regardless of time fitted.

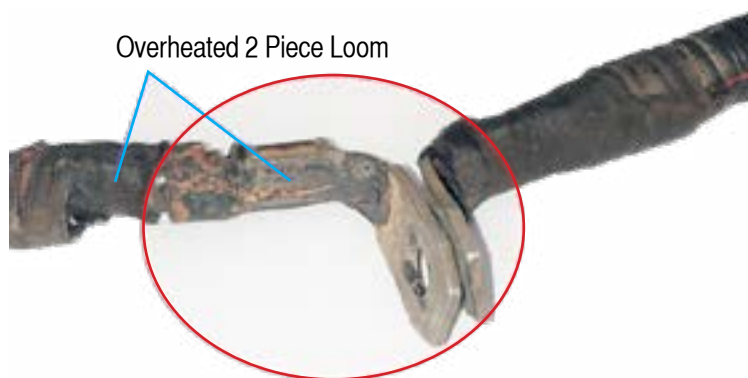
JAS has been made aware of an issue with the original wiring (Battery - Alternator Cable) on the Holden Captiva, that causes the main battery terminal stud on the solenoid to overheat.

The issue with the original loom, Part Number 22738562, is separate cable lugs that develop excessive resistance and causes overheating.

The new updated loom which GM has improved, is a one piece cable with no join at the starter solenoid battery terminal.

Please note that if not replaced with a new loom, JAS will **NOT** cover any warranty claims that has caused the main battery stud on the starter solenoid to overheat and melt the solenoid cap.
