# SNV024, SNV024GQ

## Captiva CG

Engines Z22D1 2.2 Litre Turbo Diesel

# E38-CAPTLOOM

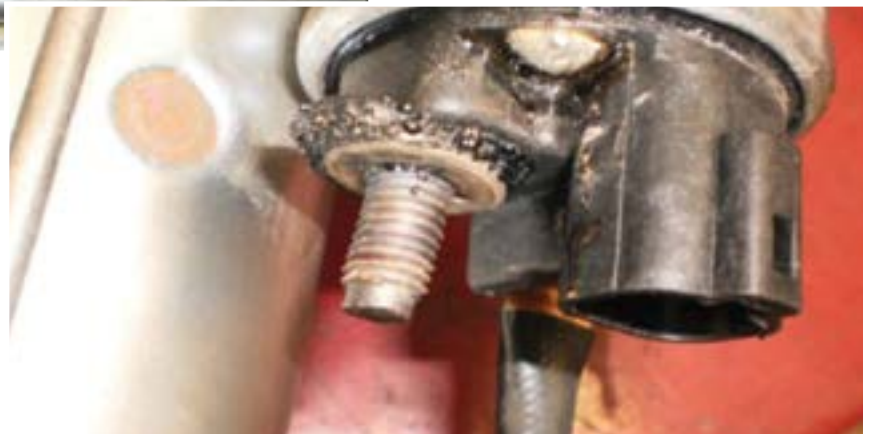
This damage to the Solenoid Stud is **NOT** a manufacturing defect but caused by external heat and any starter returned with this problem **WILL NOT** be covered by warranty regardless of time fitted.

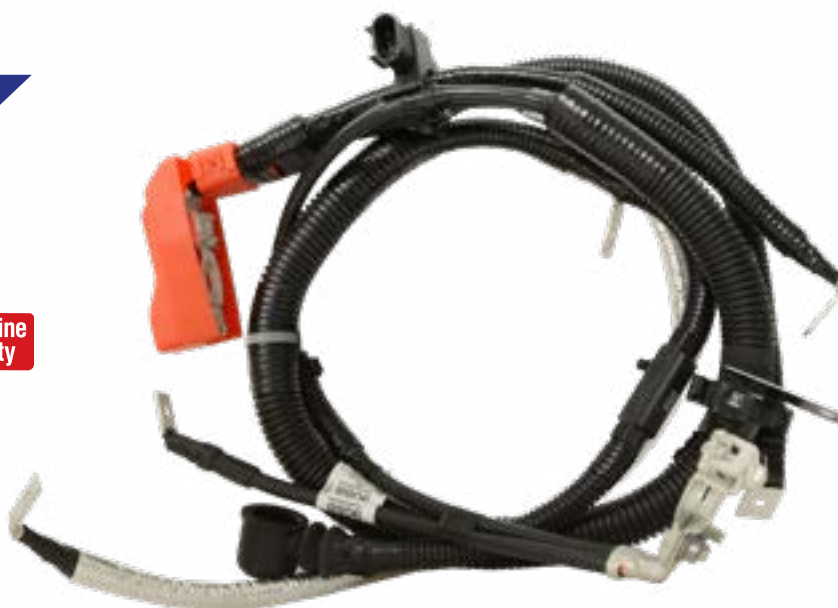
E38-CAPTLOOM

The new updated loom which GM has improved is a one piece cable with no join at the starter solenoid battery terminal.

**UPGRADED**
