## 79 Series Landcruiser Starters 428000-5645 SNJ247

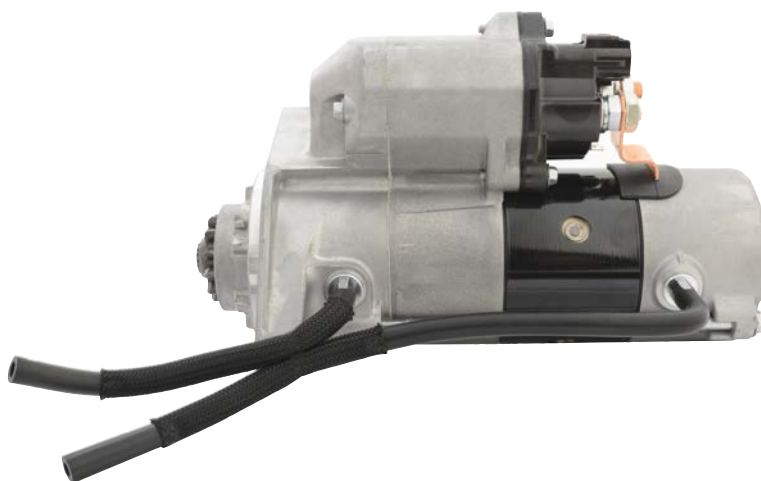
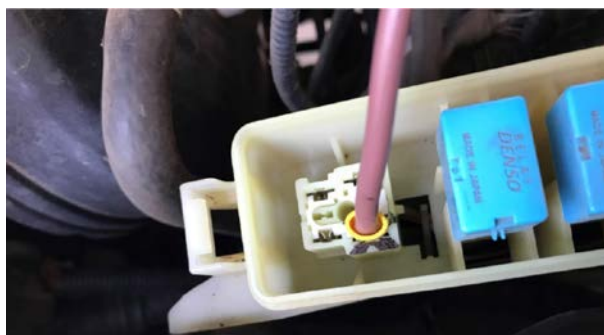
We have had a vehicle come into a branch with this fault (occasional starter clicking) being displayed at the time and found that by bypassing the solenoid wiring at the starter relay the starter operated consistently. This confirms that there is enough resistance in the solenoid activation circuit to cause the solenoid contacts to oxidise due to slow closing and subsequent arcing in turn not providing good voltage to the starter motor itself.

Position of bypass point to test Starter in Starter Relay, drivers side inner guard.
