## SND003, SND004, SND028, SND028GQ

JAS has had the above starters returned with broken drive end housings.

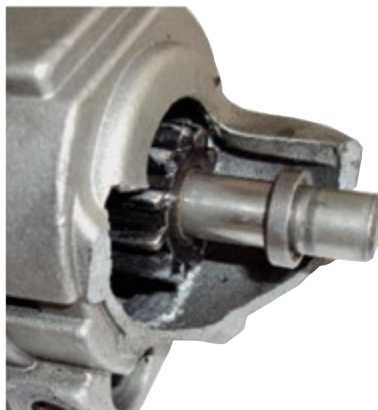
Please note that in normal operation a starter is not capable of developing enough torque to cause the drive end housing to break. Damage of this type is not covered by warranty.

This type of damage is typically caused by an engine backfire or “kickback”. General Motors have released Tech Service Bulletins addressing this issue; the cause is usually one of the following:

- Crank Position Sensors
- Fuel Pressure Regulator
- Timing Belt
- PCM or ECM
- Distributor cap
- Valve Adjustment
- Use of starting fluid
- Misaligned / improperly mounted starter, please see correct fitment of shims below.

Repairs to rectify any of the above issues should be carried out prior to fitment of new starter motor.

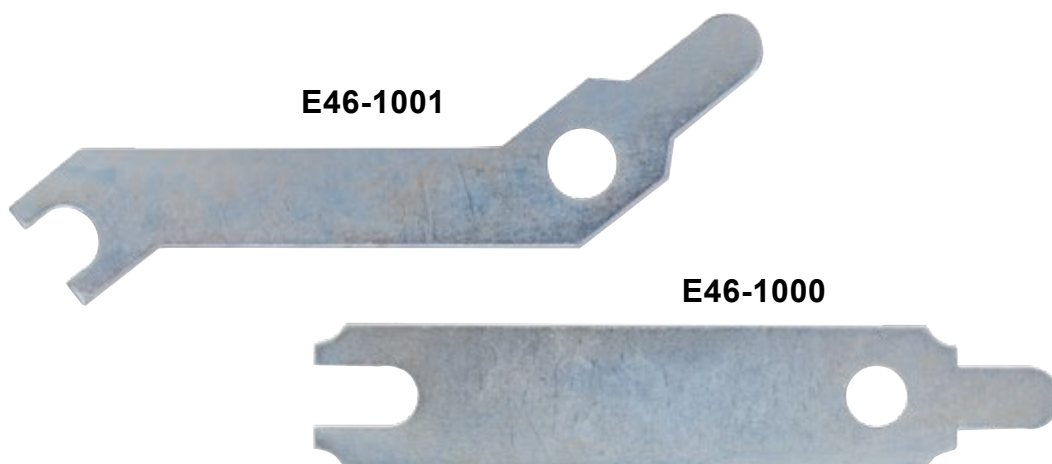
- A high pitched whining sound as the starter disengages indicates that an increase in clearance is required.
- A clanging sound when the starter is engaged indicates that a decrease in clearance is required.

- Shim(s) may be placed at both the mounting holes for gradual clearance (See Figure 1).
- For greater clearance, insert Shim(s) only at the inboard mounting hole (See Figure 2).

- Place Shim(s) only at the outboard mounting hole (See Figure 3).
