## Oil contamination & Warning Light Failure on fitment **ANJ087** / **ANJ087GQ** / **ARJ204** Model: Ford Falcon AU-BA

The following reports on 2 problems with **ANJ087** / **ANJ087GQ** / **ARJ204** Alternators fitted to late model Ford Falcon AU-BA

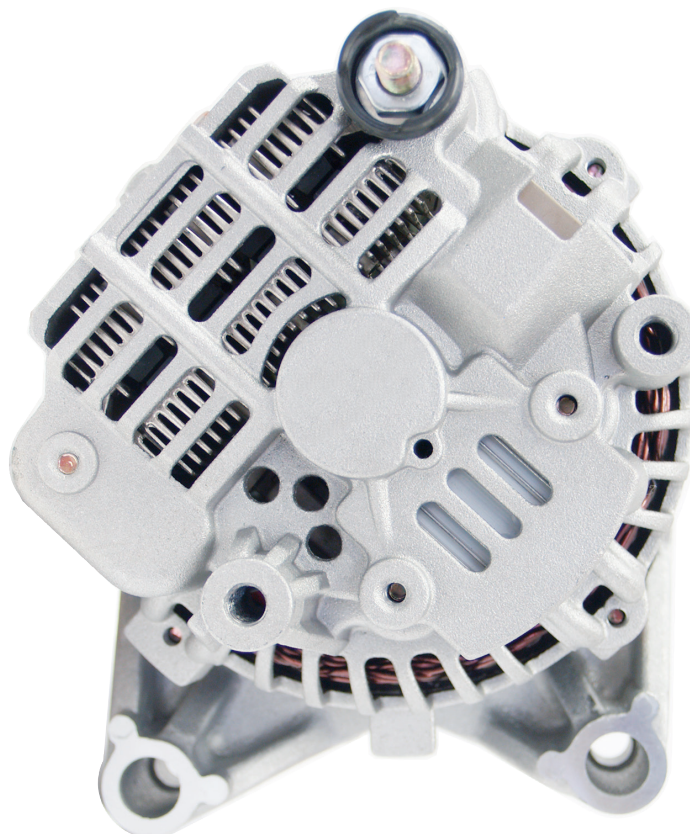
\* Inadvertently connecting battery supply to the warning light terminal of the regulator plug. There are many wiring diagrams in circulation relating to this unit and there may be incorrect versions in the market leading to the technician unknowingly incorrectly connecting wiring when replacing the plug.

**Please refer to Diagram below.**

Please ensure correct connection as per diagram attached and any leaks from the power steering system are repaired.
