## ANJ087, ARJ204 - AU BA Ford Alternators

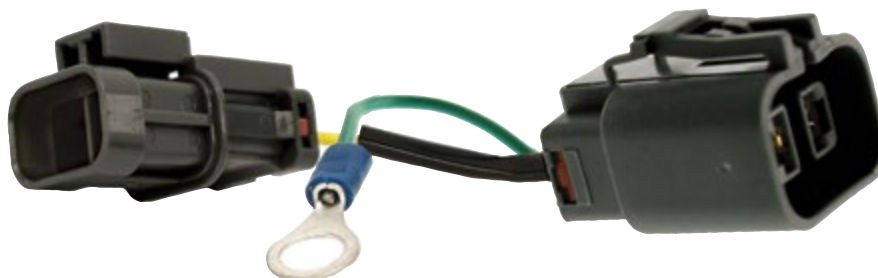
1. Early model AU Fords had an Autolite Alternator with a 3 pin plug. There would be very few of these left that have not been converted with adaptor lead E38-2019 to suit an ANJ087. Using this adaptor, there is only a need to find the warning light wire in the 3 pin plug on the vehicle – cut this wire out of the plug and crimp on a 6.3mm push on terminal and push this into the yellow wire in the adaptor. The green wire with ring terminal goes onto the battery stud on the Alternator as the battery sense wire.
