## SNB008 To Suit V6 3.8 VN-VY

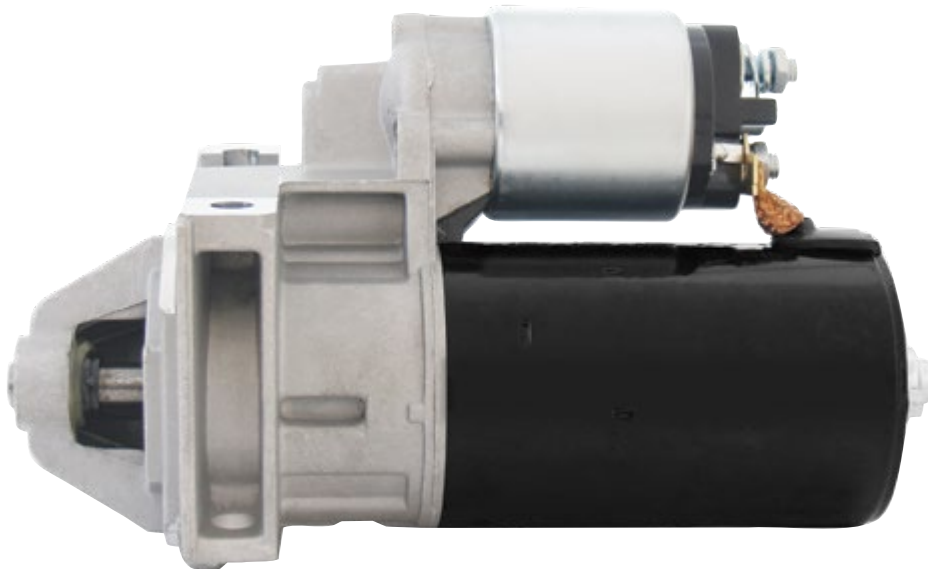
Please note that in normal operation a starter is not capable of developing enough torque to cause the drive end housing to break. Damage of this type is not covered by warranty.

This type of damage is typically caused by an engine backfire or “kickback” most likely caused by one of the following.....

- Crank Position Sensors
- Fuel Pressure Regulator
- Timing chain wear
- PCM or BCM
- Valve Adjustment
- Use of starting fluid
- Misaligned / improperly mounted starter. This starter should not require the use of shims. But correct mounting bolts are critical please refer to Tech Tip 32 on Mounting Bolts.
- For Vehicles on LPG Gas please ensure correct tuning and all air intake hoses are intact.
