# ARJ204

## Fitting a Mitsubishi Alternator to replace a Motorcraft Alternator

### Attention Fitter

Warning Lamp Failure and Oil Contamination of ARJ204 Alternators Units Failure Due to Conditions of Service, Not Manufacturing Fault.

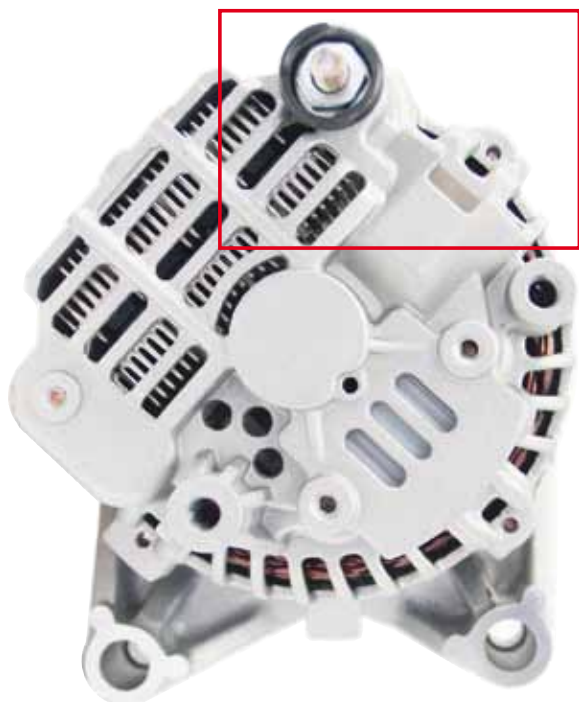
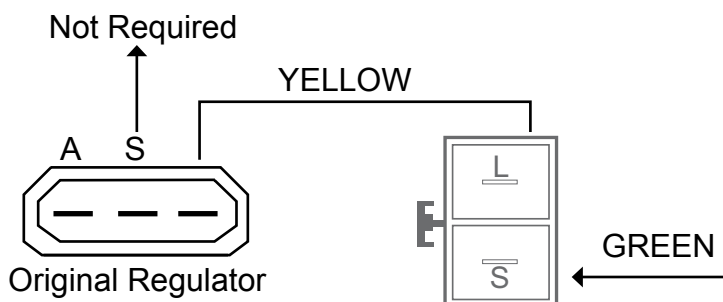
1. POWER STEERING FLUID leaking into the alternator from power steering pump and damaging brushes.
2. Please ensure wiring is correct (Please refer to our diagram below)

(\* In cases where a Motorcraft Alternator is being replaced with an ARJ204, JAS supplies an adaptor plug to simplify the connection process. The Green wire of the adaptor plug is pre connected to the B+ terminal on the ARJ204 and the Yellow wire of the adaptor plug MUST be connected to the warning light wire in the original 3 pin plug from the vehicle. This should be identified before being connected to the yellow wire of the adaptor plug as connecting battery power (from the vehicle) to this terminal will result in regulator failure.
