## Twisted Splines On Starter

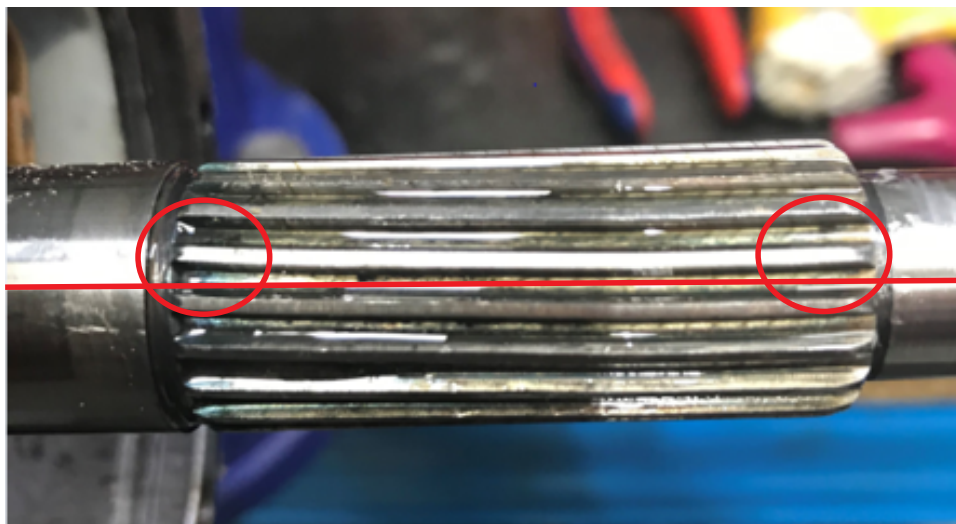
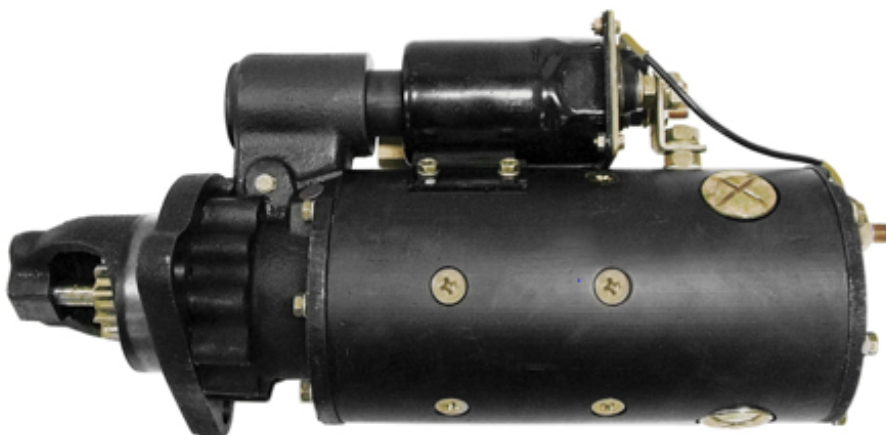
We have not seen this for some time but it is still an issue as can be seen by the photo below. From September 2019

SND019 is a 24 volt 50MT Delco style Starter that develops 8.5 kilowatts.

When that 8.5 kilowatts comes up against an immovable force such as an engine that has a hydraulic lock up due to coolant in a cylinder the result is twisting of the splines on the armature as can be seen above. The question that the customer can often ask is why does this not happen every start? The engine will not always stop in a position that allows a cylinder to fill with coolant typically from a leaking head gasket. If the cylinder with the issue has the piston stop at TDC or on the down stroke after compression or on the exhaust stroke this will not occur.

This is not a weakness or softness in the splines but due to the inability of the starter to turn the motor over. We have seen this in many model starters not just 50mt styles, in smaller starters such as SND004 and SND003 this can result in broken housings, this is covered in Tech Tip 31.
