ANJ110 / ANJ110GQ

JAS have had ANJ110 & ANJ110GQ Alternators to Suit Triton and Pajero with a 6G72 or 6G74 3.5 litre Engines being returned with Engine Oil contamination. This is commonly caused by 2 issues.

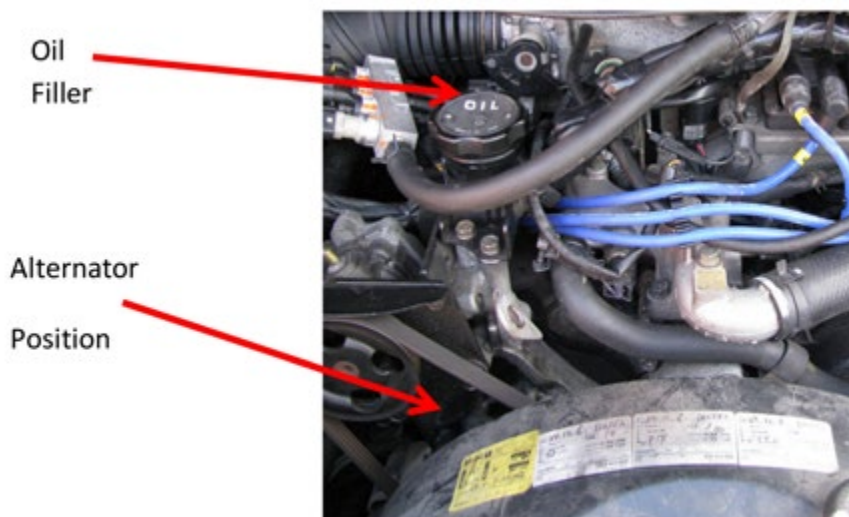
1. Overfilling a small container that is the initial engine oil fill point which drains into the RHS rocker cover with engine oil. If this is overfilled it overflows over the Alternator below it. See picture below.

2. The second source of Oil contamination on these is leaking Rocker Cover Gaskets.

Slip Ring and Brush damage results from this contamination, ultimately creating a copper paste from the slip rings as they wear and shorting out the Voltage regulator.
