## ARJ093 Pulley Slipping

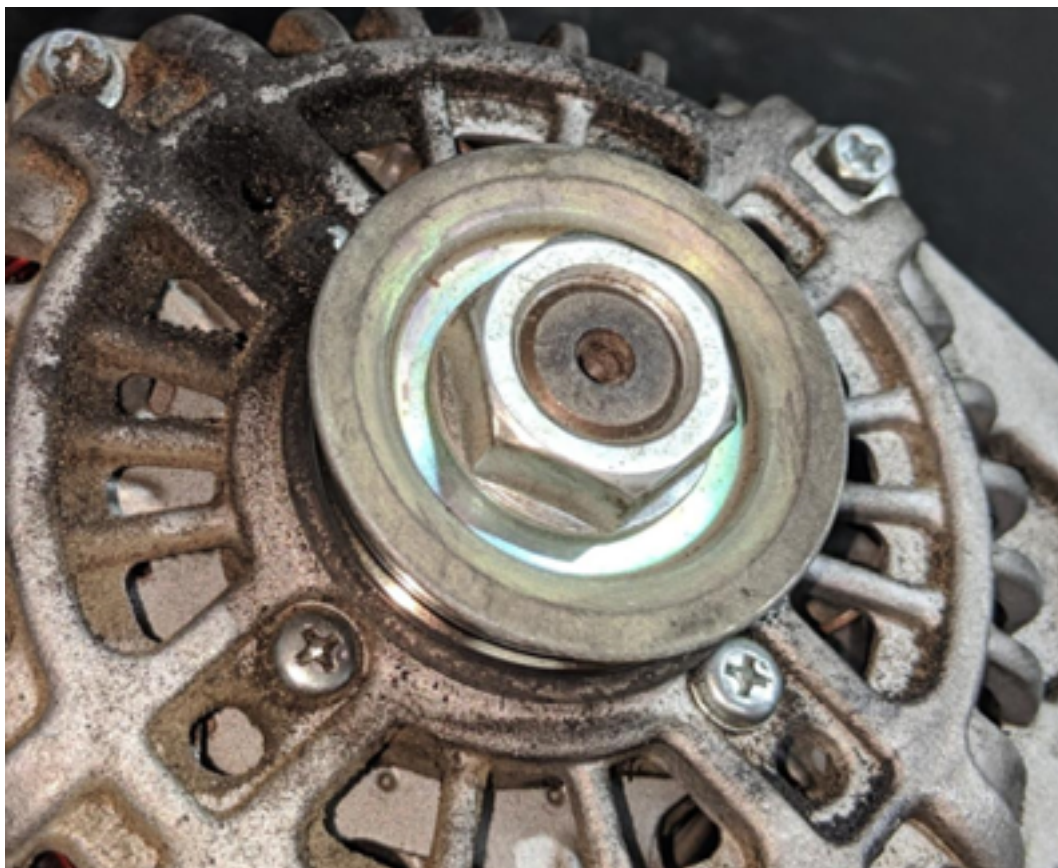
The issue that commonly comes up is due to belt slippage. These alternators are fitted OE with quite a small diameter pulley and also a quite narrow belt at 3PK.

It is important to check that the belt is in very good condition and adjusted correctly as with minimal wrap around and a narrow belt they will slip very easily and once they do slip will generate quite a lot of heat and fail quickly.

Please take note of the picture below where you will notice the amount of belt dust and discolouration of the pulley due to heat. This Alternator was returned with the complaint that the belt fails but was working perfectly with no signs of polling or being difficult to spin. The problem here was most likely an incorrectly adjusted belt or new belt fitted and then not re-tensioned after initial running.

JAS have also had information back from customers where this has been caused by a worn tensioner causing belt misalignment and slippage. Please check all components of the belt drive line when replacing any Alternator.
