## ANJ507 Mazda Bravo and Ford Courier

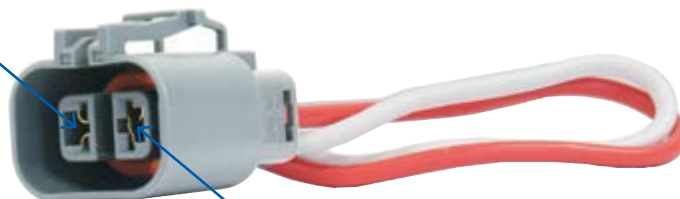
Warning light wire from dash

Sense Wire live at all times

If the customer's preference is a new ANJ507 or ANJ507GQ they will need to modify the connection plug to an E38-2010. This is done by first identifying the battery sense wire which is at one end of the 3 pin plug on the vehicle and live at all times with ignition on or off. This wire needs to be cut out of the 3 pin plug on the vehicle and connected to the wire that lines up with the "S" terminal in the E38-2010 2 pin connector to the alternator.

The other end terminal in the vehicle 3 pin plug should be warning light and can be identified as coming alive with ignition on and if earthed through a test light with a 5watt incandescent globe should bring the alternator dash light on. This wire needs to be cut out of the 3 pin plug and joined to the lead corresponding to the "L" terminal on the E38-2010 and Alternator.
