## SND003, SND004, SND028, SND028GQ

JAS has had the above starters returned with broken drive end housings.

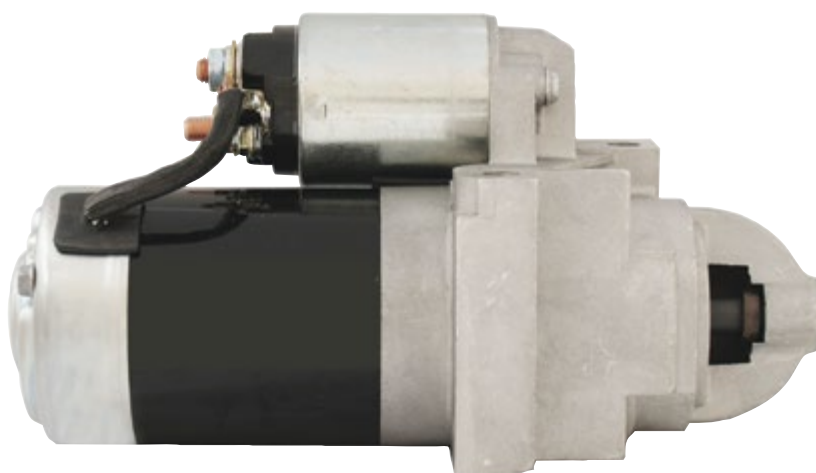
Please note that in normal operation a starter is not capable of developing enough torque to cause the drive end housing to break. Damage of this type is not covered by warranty.

This type of damage is typically caused by an engine backfire or “kickback”. General Motors have released Tech Service Bulletins addressing this issue; the cause is usually one of the following:

- Crank Position Sensors
- Fuel Pressure Regulator
- Timing Belt
- PCM or ECM
- Distributor cap
- Valve Adjustment
- Use of starting fluid
- Misaligned / improperly mounted starter, please see correct fitment of shims below.

Repairs to rectify any of the above issues should be carried out prior to fitment of new starter motor.
