ANJ110 / ANJ110GQ

JAS have had ANJ110 & ANJ110GQ Alternators to Suit Triton and Pajero with a 6G72 or 6G74 3.5 litre Engines being returned with Engine Oil contamination. This is commonly caused by 2 issues.

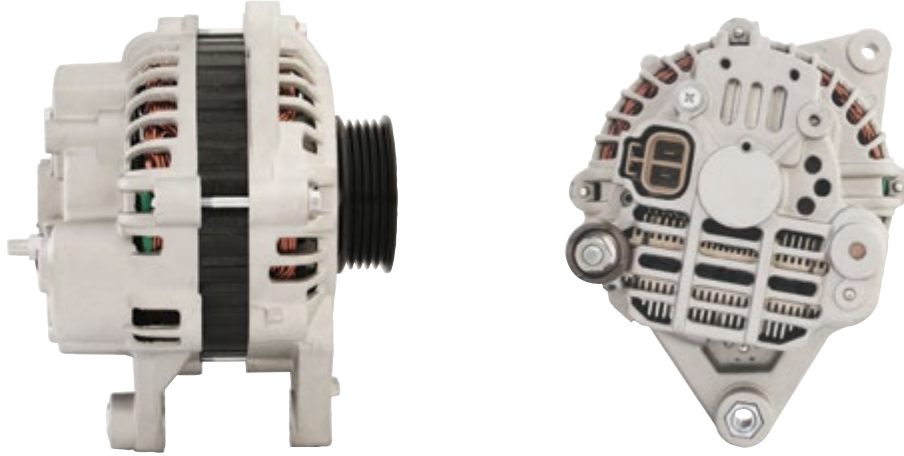
2. The second source of Oil contamination on these is leaking Rocker Cover Gaskets.

Slip Ring and Brush damage results from this contamination, ultimately creating a copper paste from the slip rings as they wear and shorting out the Voltage regulator.

There is a Warning Sheet in the packaging with this Alternator to advise the fitter of this issue.

Engine Oil Damage in the Alternator is not a warrantable fault.
