## VpCI™-386 Acrylic Primer/Topcoat

**ANJ006EP / ANJ061EP / ANJ220EP / ANJ233EP / ANJ249EP / ANJ409EP**

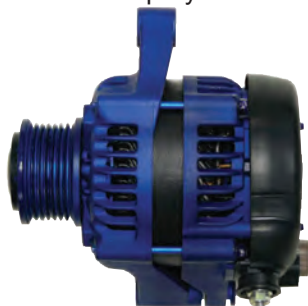
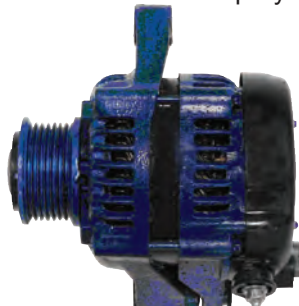
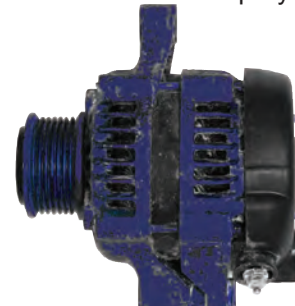
### Anti-Corrosion Coated Unit - Salt Spray Test Results

Before Salt Spray Test

After 192 hours Salt Spray Test

3 Days after end of Salt Spray Test
