## Smart Battery Testers

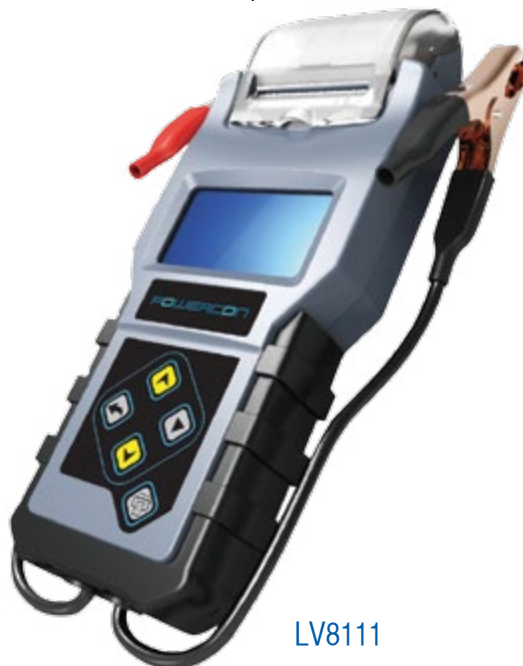
Modern battery testing is achieved using a “Smart Battery Tester” such as an LV8111 which will give a quick, accurate and printable condition report on the state of the Battery relative to the capacity printed on its label or case, along with Charging System and Starter Function. It will also report Battery Health, Voltage and internal Resistance. LV8110 will also provide this testing without the printer function.
