JAS Product Advice on Starters with identical appearance but different out of mesh measurements

JAS Product Advice Starters Held in Mesh

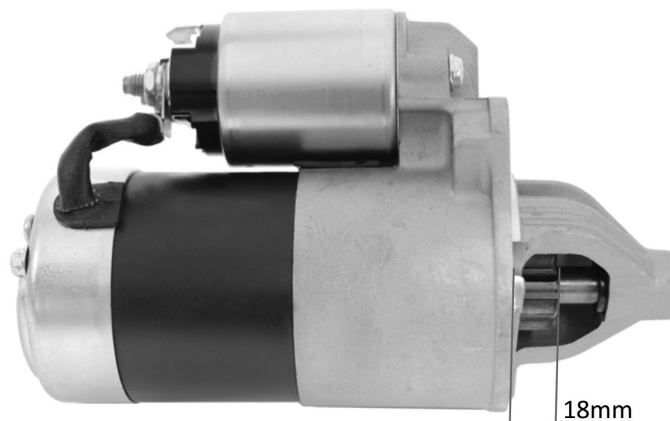
The most frequent time we see this issue is with SNJ095 and SNJ082 and the GQ versions. Looking at SNJ095 below the pinion at rest measurement distance is 10mm.
